**MARINE INVESTIGATION REPORT**  
**M01L0112**

**MAJOR WATER INGRESS**

**SCALLOP DRAGGER *ALEX B. 1***

**29 SEPTEMBER 2001**

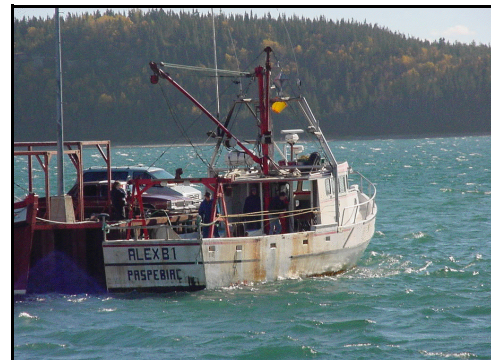
**Photograph 1.** The *Alex B. 1*  
(October 2001)

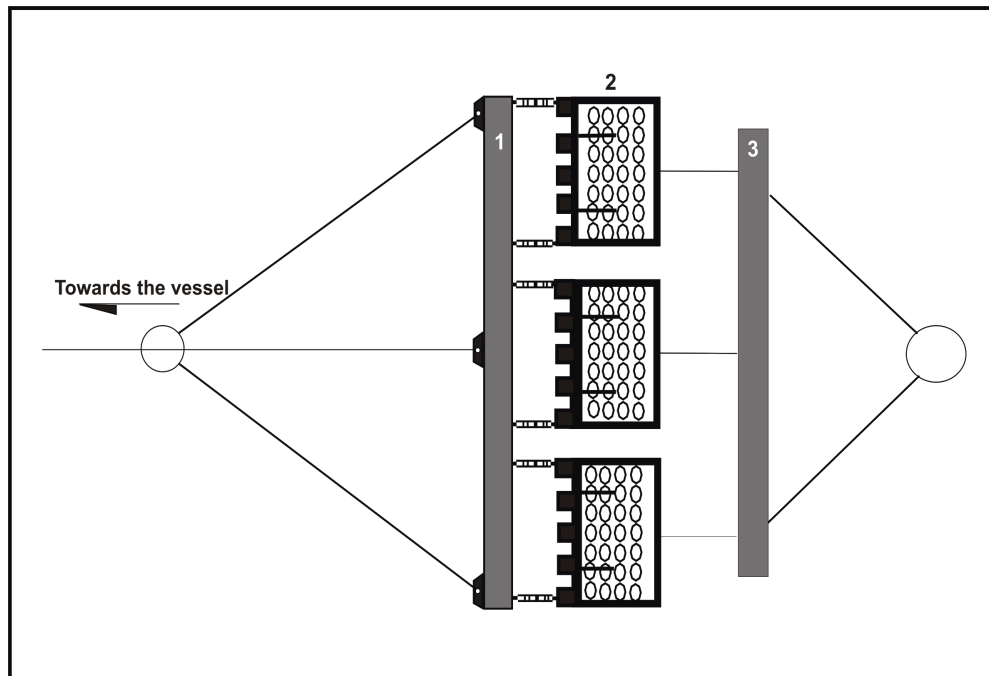
The scallop drag used by the *Alex B. 1* is made up of three steel scallop rakes (see Figure 2). The three rakes (2) are rigged side-by-side and fastened to a steel beam (1), which is in turn fastened to a bridle and drag line. A wooden beam is fastened aft of the three rakes (3) to stabilize the drag on the seabed.

Figure 2. The scallop drag
